**LIMITED ASBESTOS CONTAINING MATERIAL  
INSPECTION AND ASSESSMENT: 3131 SOUTH  
VIRGINIA STREET, RENO, NEVADA CONDUCTED  
MARCH 17/APRIL 17, 2023**

**RE: LIMITED ASBESTOS CONTAINING MATERIAL INSPECTION AND ASSESSMENT: 3131 SOUTH VIRGINIA STREET, RENO, NEVADA**

**AREA OF IMPROPER ASBESTOS DISTURBANCE  
AND REMOVAL**

## **PHOTOGRAPHIC DOCUMENTATION**

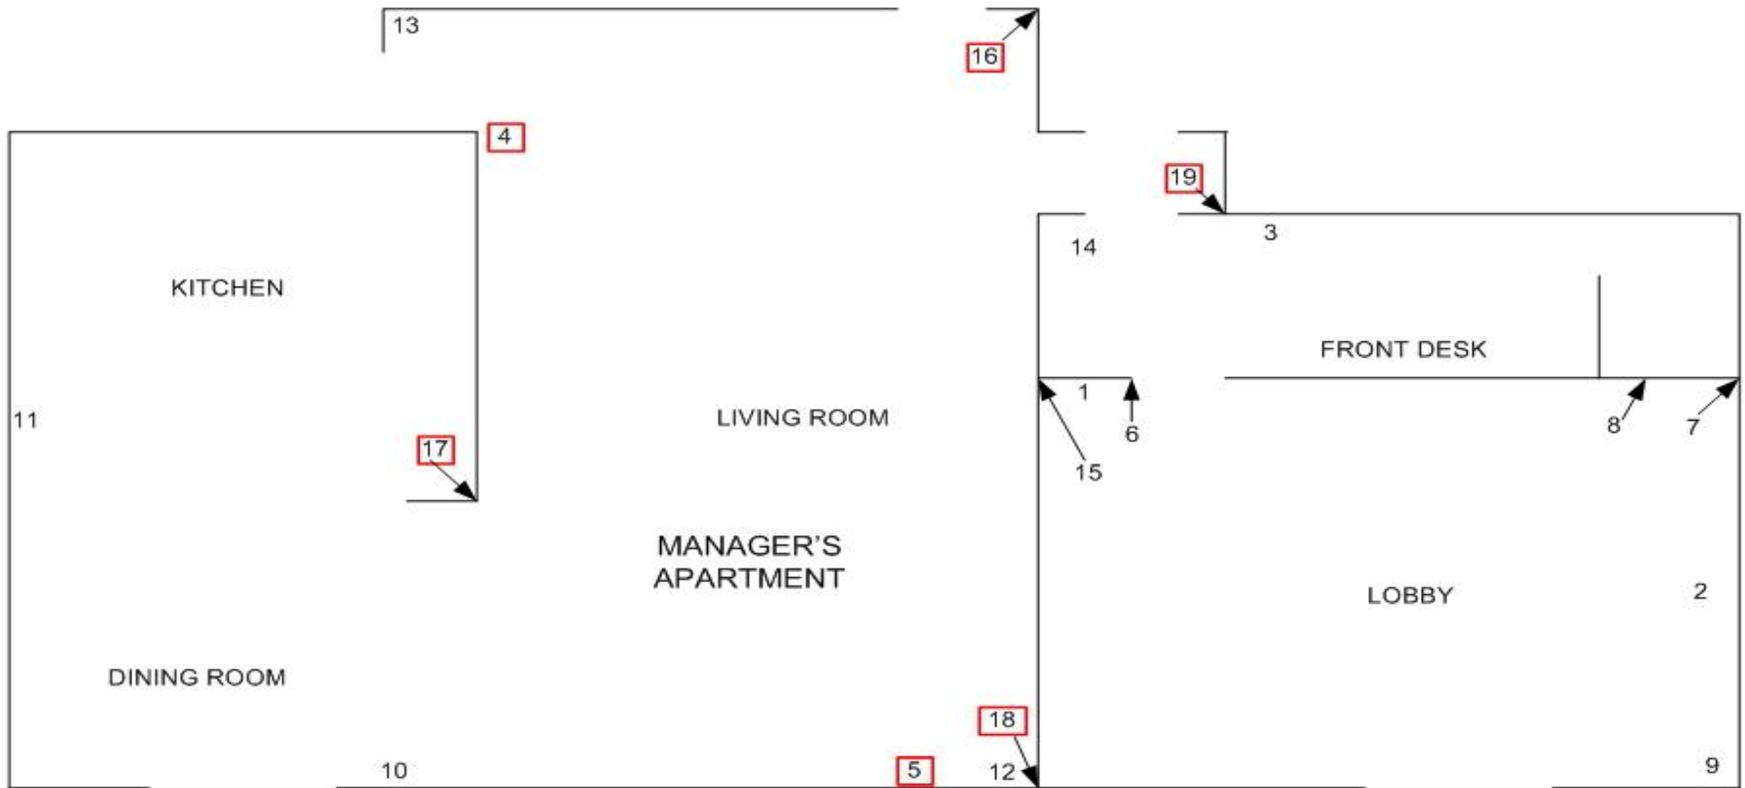
<b>C&amp;G Environmental Consulting, Inc.</b>			
Figure 1 Approximate Locations of Bulk Samples 3131 S. Virginia Street, Reno			
Proj. No. SSC01031723CC	Client: Vagabond Inn	Date: 4-23-23	By: G. Johnson

Analytical results indicated that acoustic ceiling texture, wall texture, and joint compound materials were positive for containing greater than 1% Chrysotile asbestos in the manager’s apartment area of the building. No ACM was identified in samples collected from the front desk/lobby area.

- Denotes Location of Asbestos Containing Sample

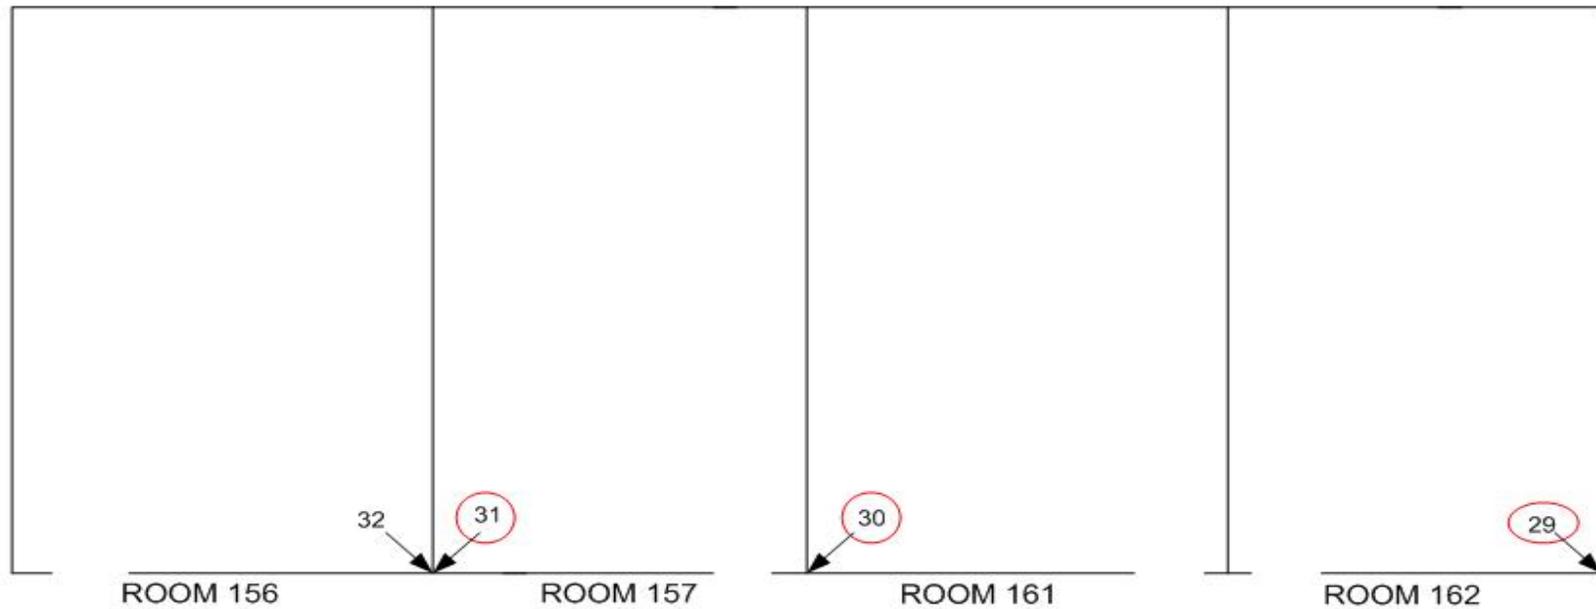
- Denotes Location of <1% Asbestos Containing Sample

Therefore, in the event the drywall joint compound materials that were identified to contain <1% in rooms 157, 161, & 162 will be disturbed as a result of a demolition/renovation project, C&G Environmental Consulting recommends that the following procedures are acknowledged in order to maintain regulatory compliance and reduce liability and health concerns:

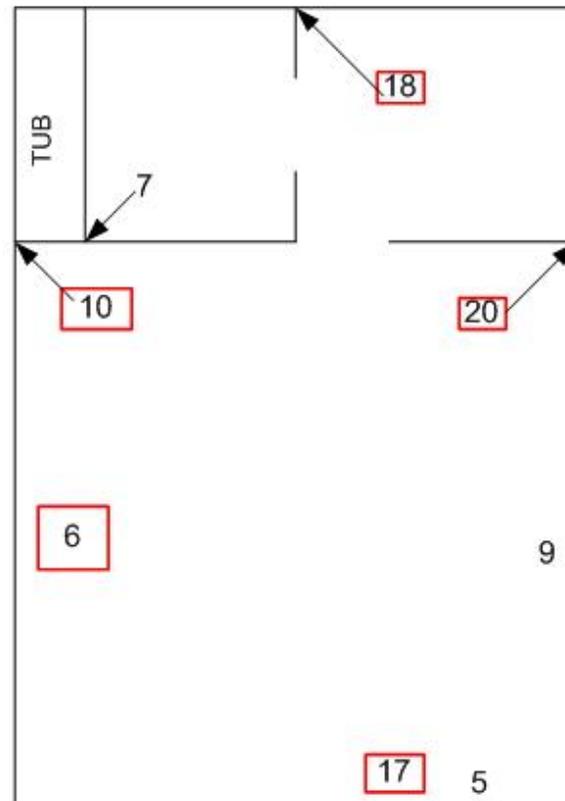
ROOMS 119, 133, 149, 153, 157, 249

- Denotes Location of Asbestos Containing Sample

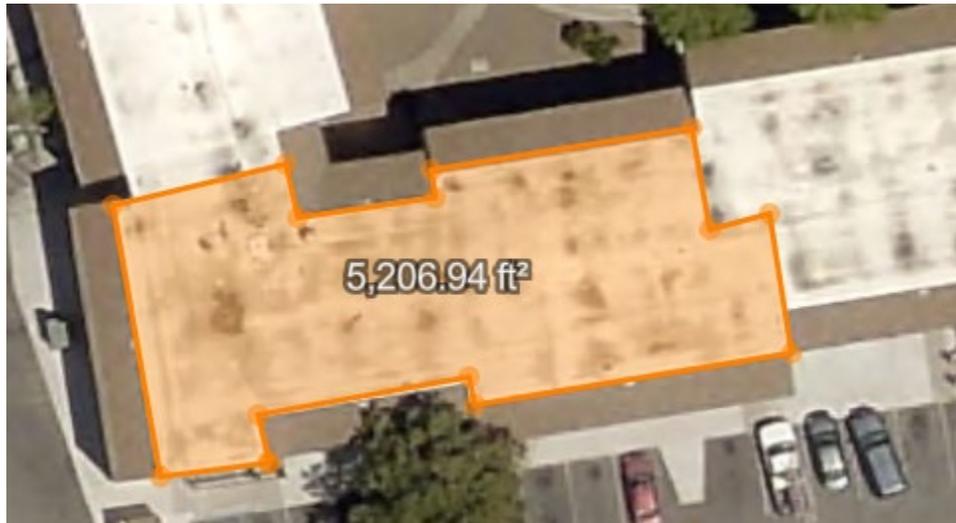
## **Area of Disturbance**

This image represents the area where the spray acoustic ceiling texture was improperly removed and/or disturbed. The disturbance occurred on the first and second floor of the building, in total disturbing approximately 10,000 square feet of asbestos containing material.

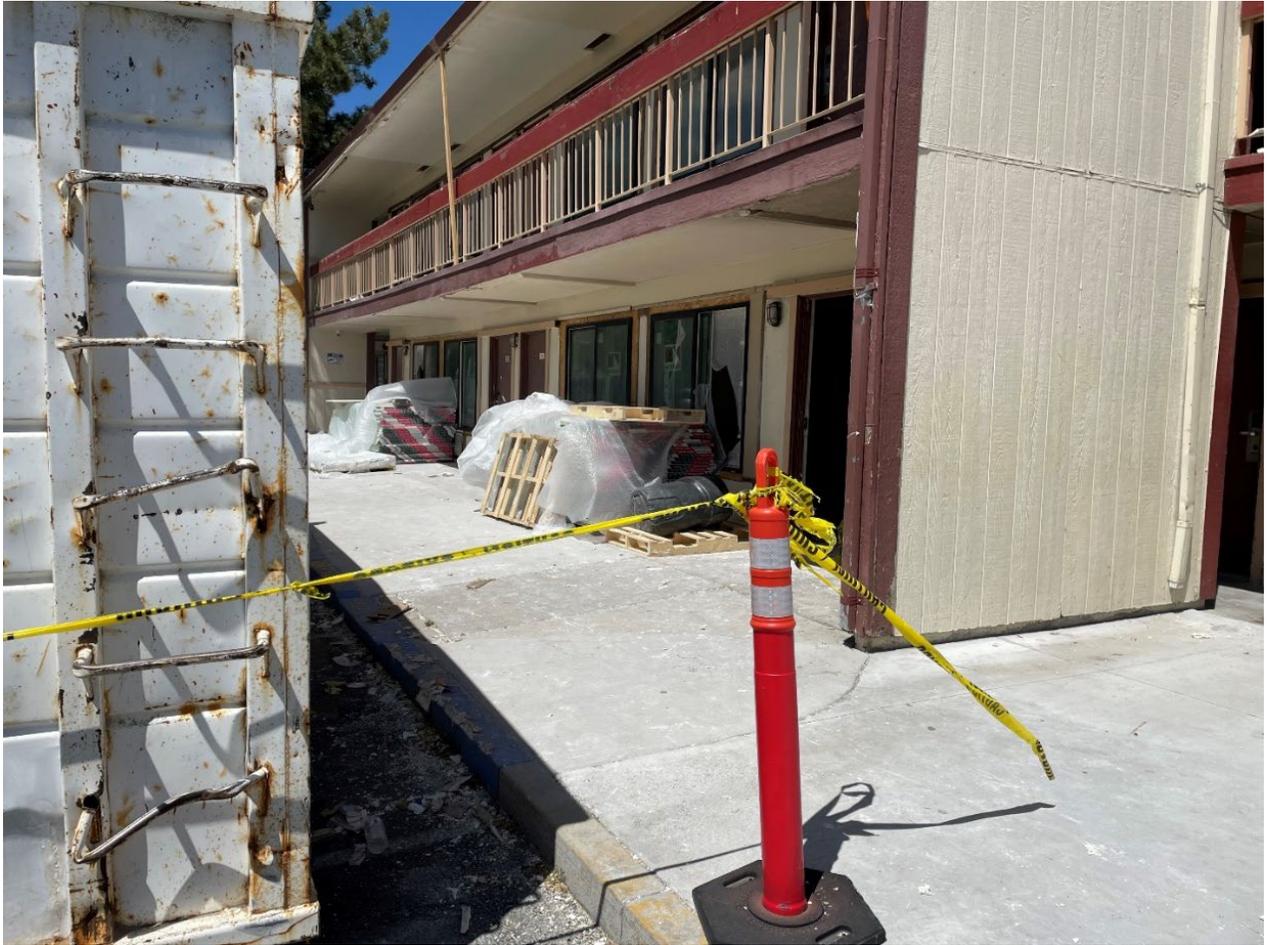
Image of the work area on the south side of the east/west oriented portion of the motel. The white debris on the sidewalk and the parking lot contains asbestos containing spray acoustic ceiling texture.

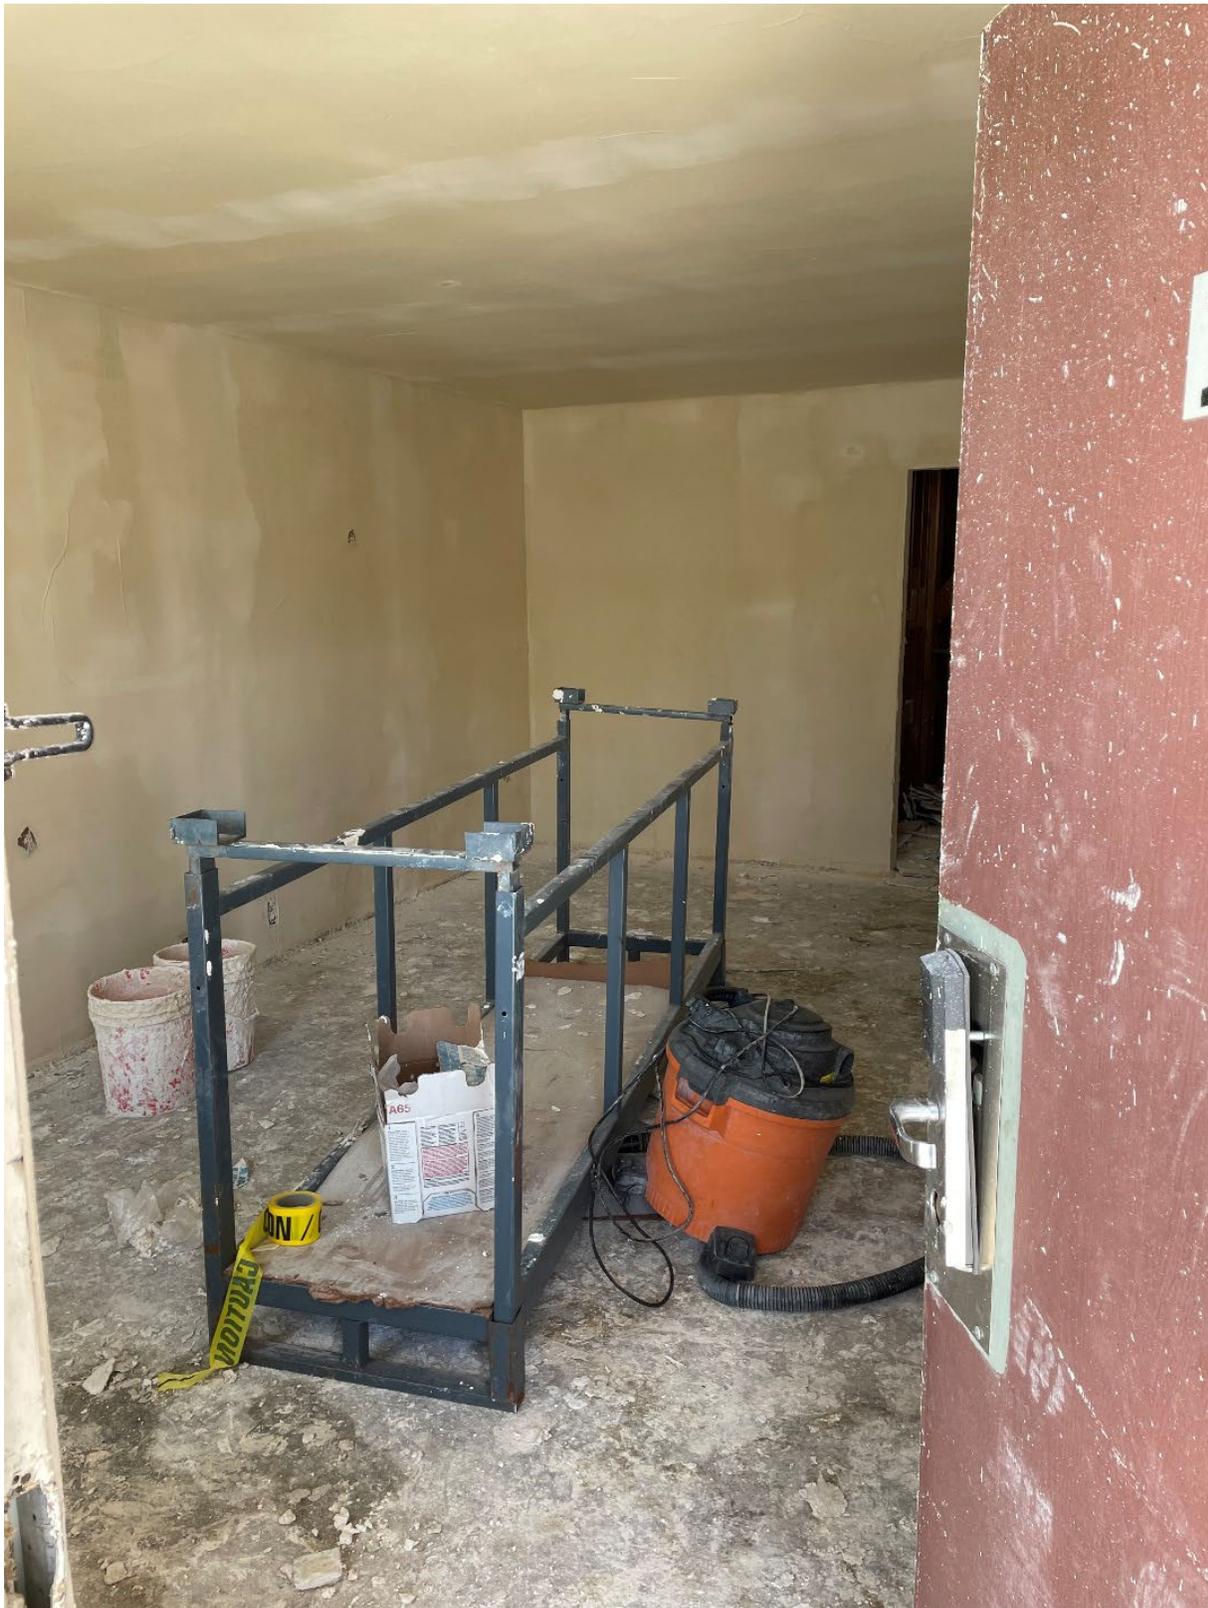
**Photograph 2**

Image of the interior of Room 155. This photograph is an example of a room during renovation where the asbestos containing spray acoustic ceiling was removed. The walls and ceiling have newly applied joint compound. The floor is covered in asbestos containing spray acoustic ceiling texture debris.

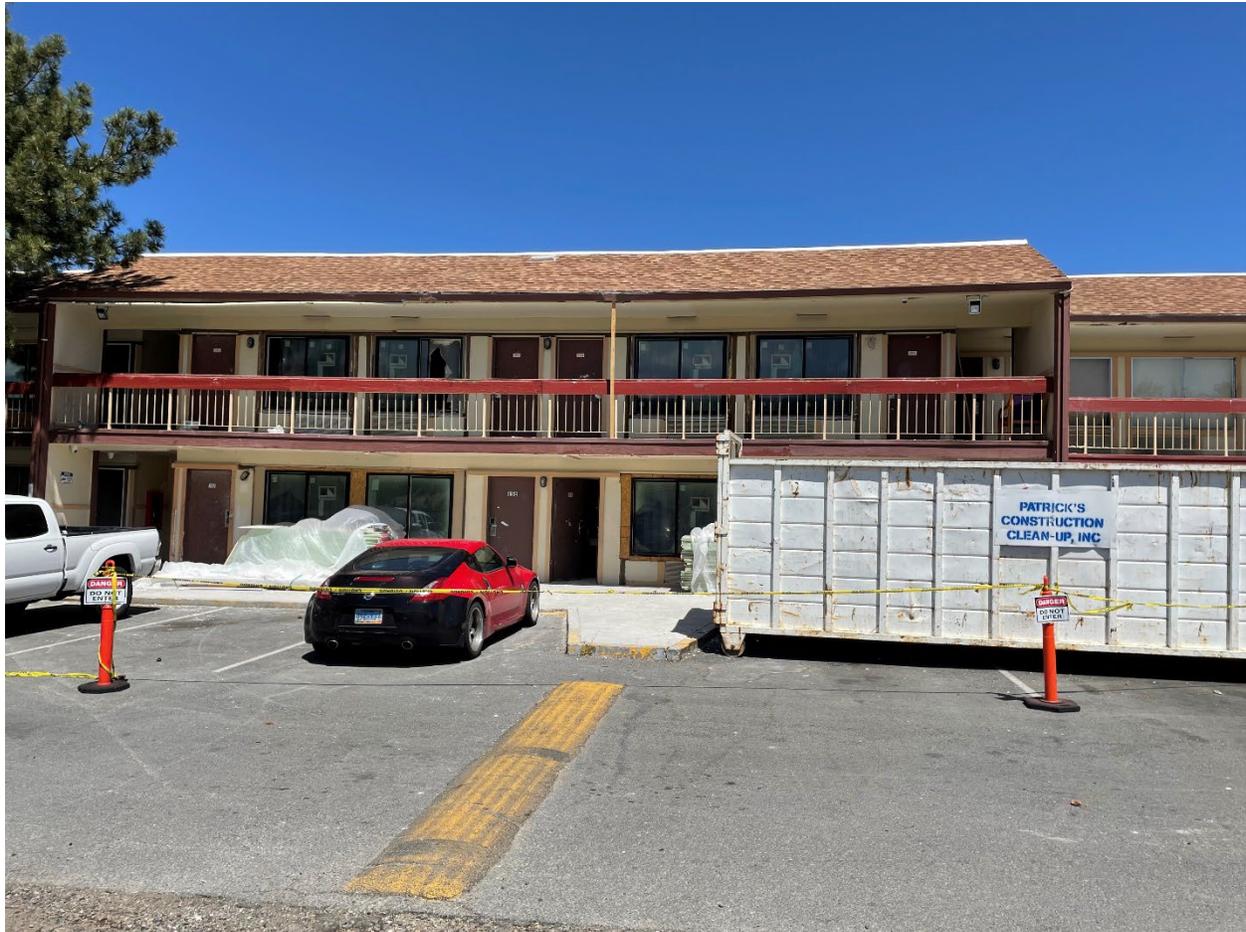
**Photograph 3**

This image demonstrates the work area on the south side of the facility.

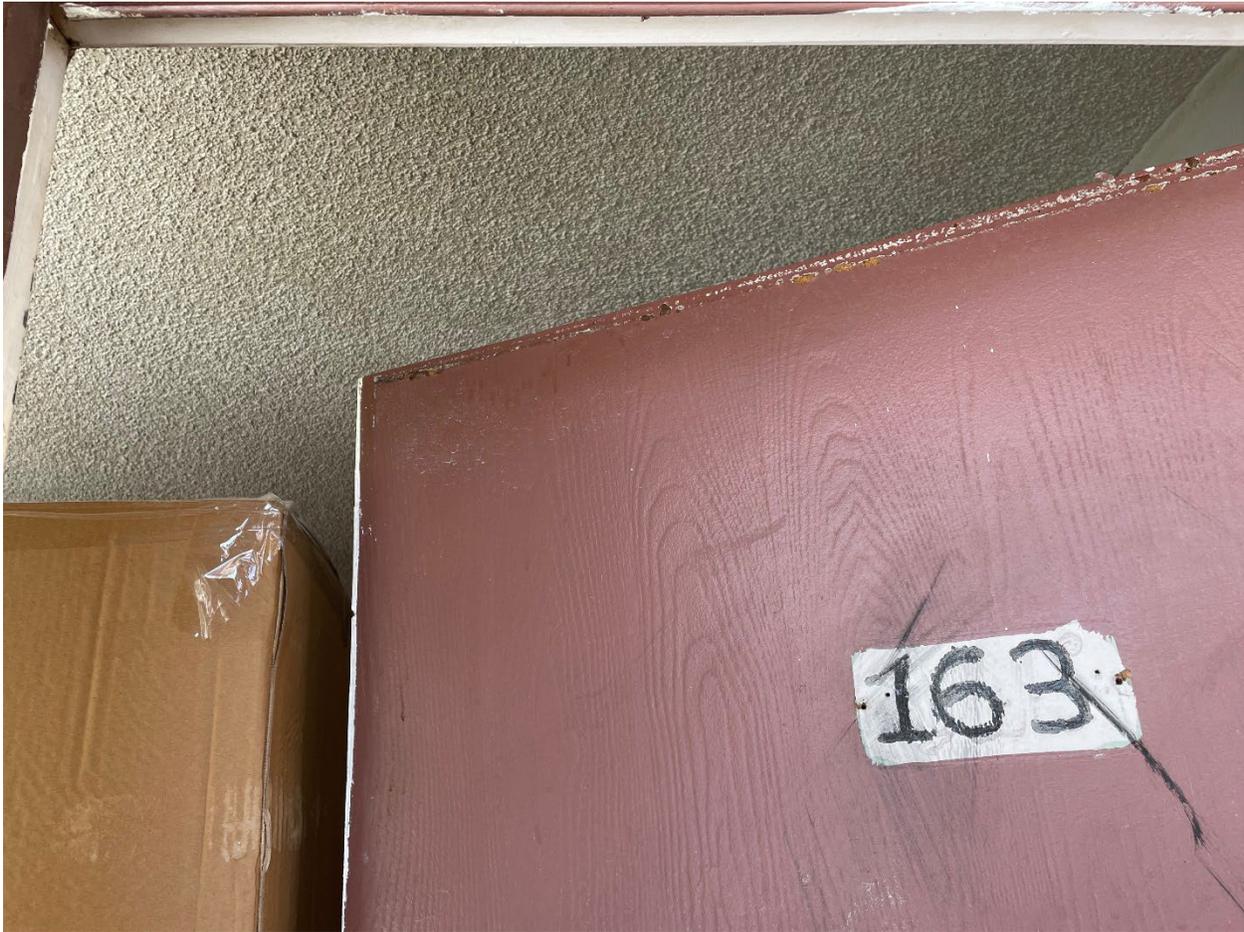
**Photograph 4**

This image demonstrates a guest room which was not being renovated at the time of the response. This room is several doors to the east of the guest rooms actively being renovated. This is an example of the asbestos containing spray acoustic ceiling texture present in the guest rooms at the facility.

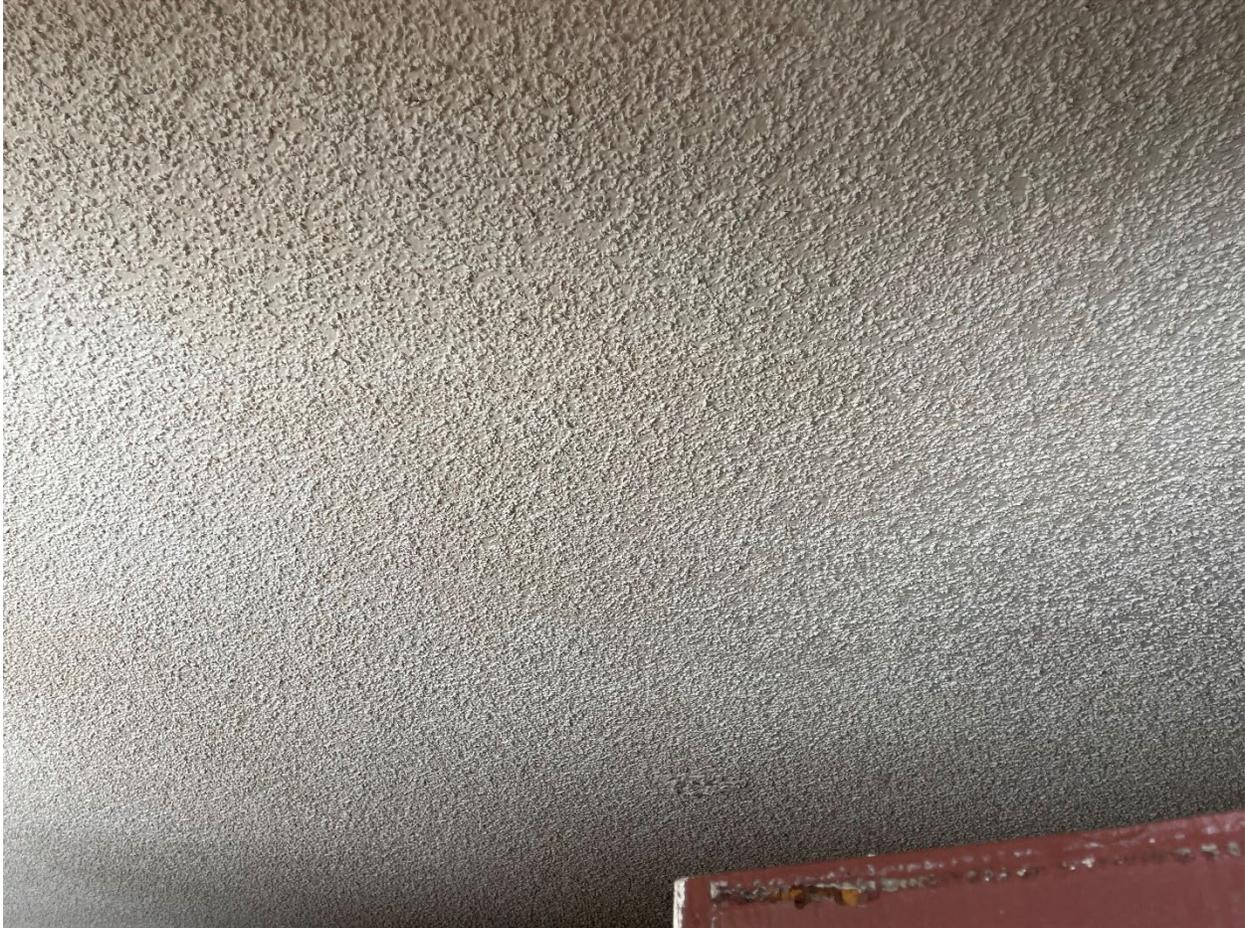
**Photograph 5**

This photo is a close-up of the spray acoustic ceiling in room 163. This image demonstrates a guest room which was not being renovated at the time of the response. This room is several doors to the east of the guest rooms actively being renovated. This is an example of the asbestos containing spray acoustic ceiling texture present in the guest rooms at the facility.

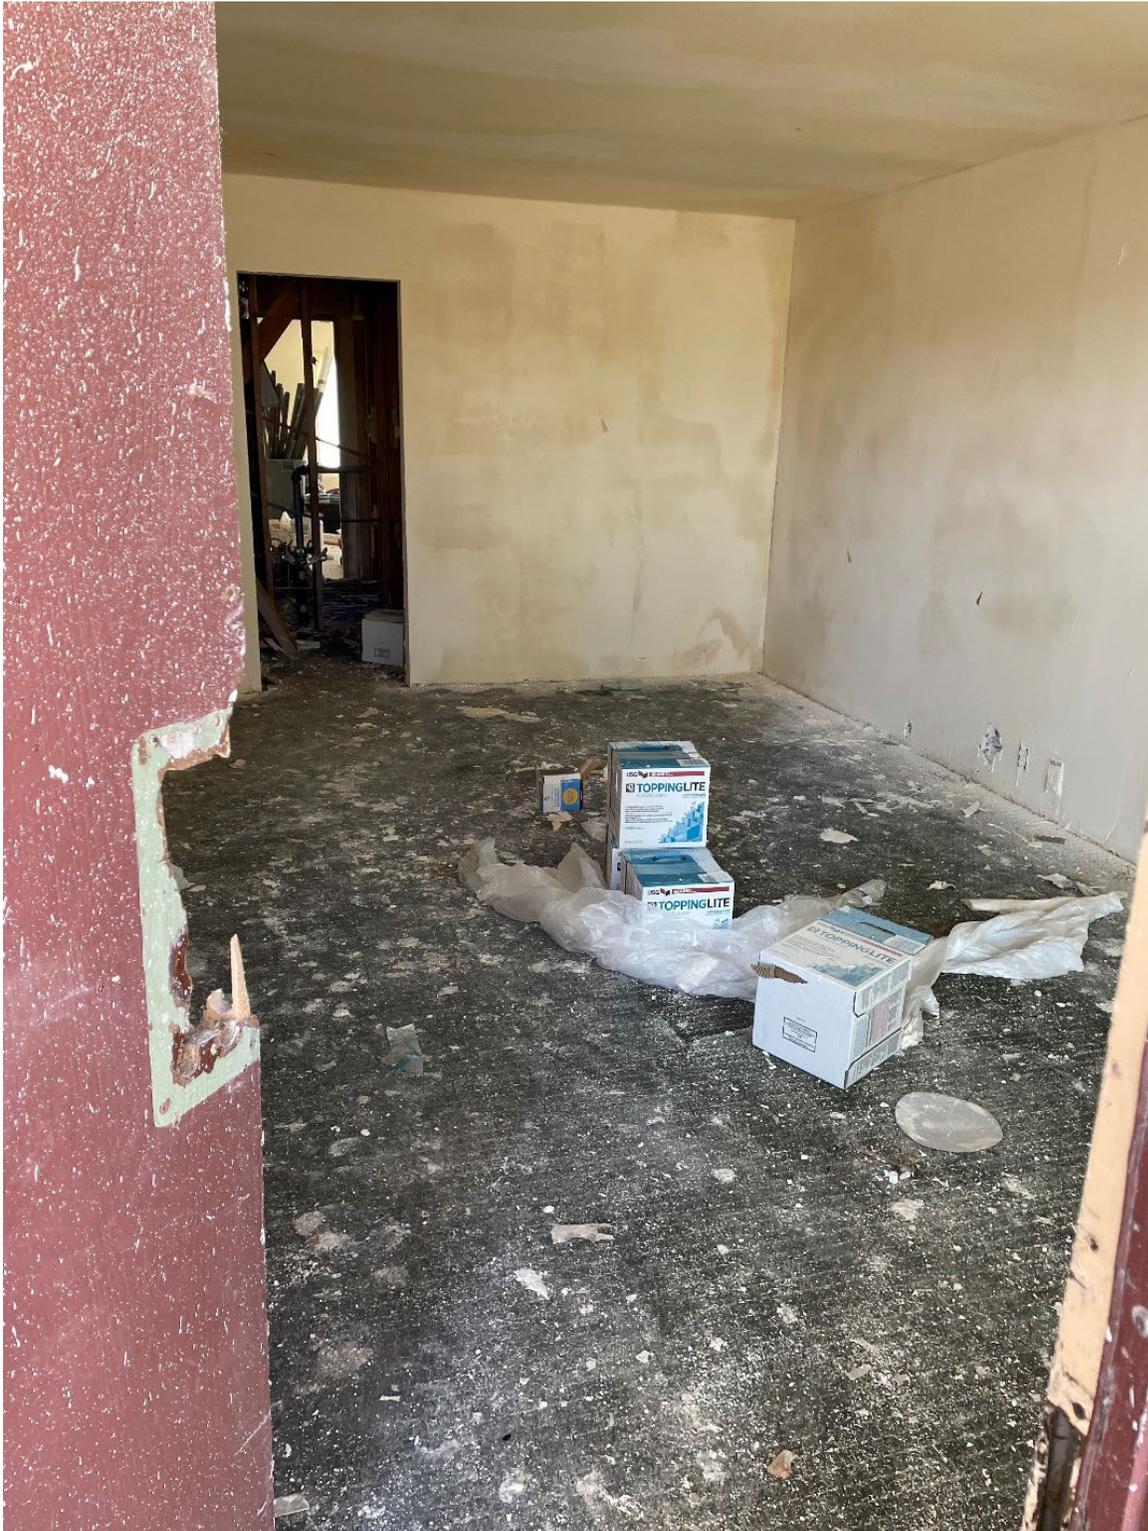
**Photograph 6**

This image demonstrates the extent of the interior renovation of room 118. This photograph is an example of a room during renovation where the asbestos containing spray acoustic ceiling was removed. The walls and ceiling have newly applied joint compound. The floor is covered in asbestos containing spray acoustic ceiling texture debris.

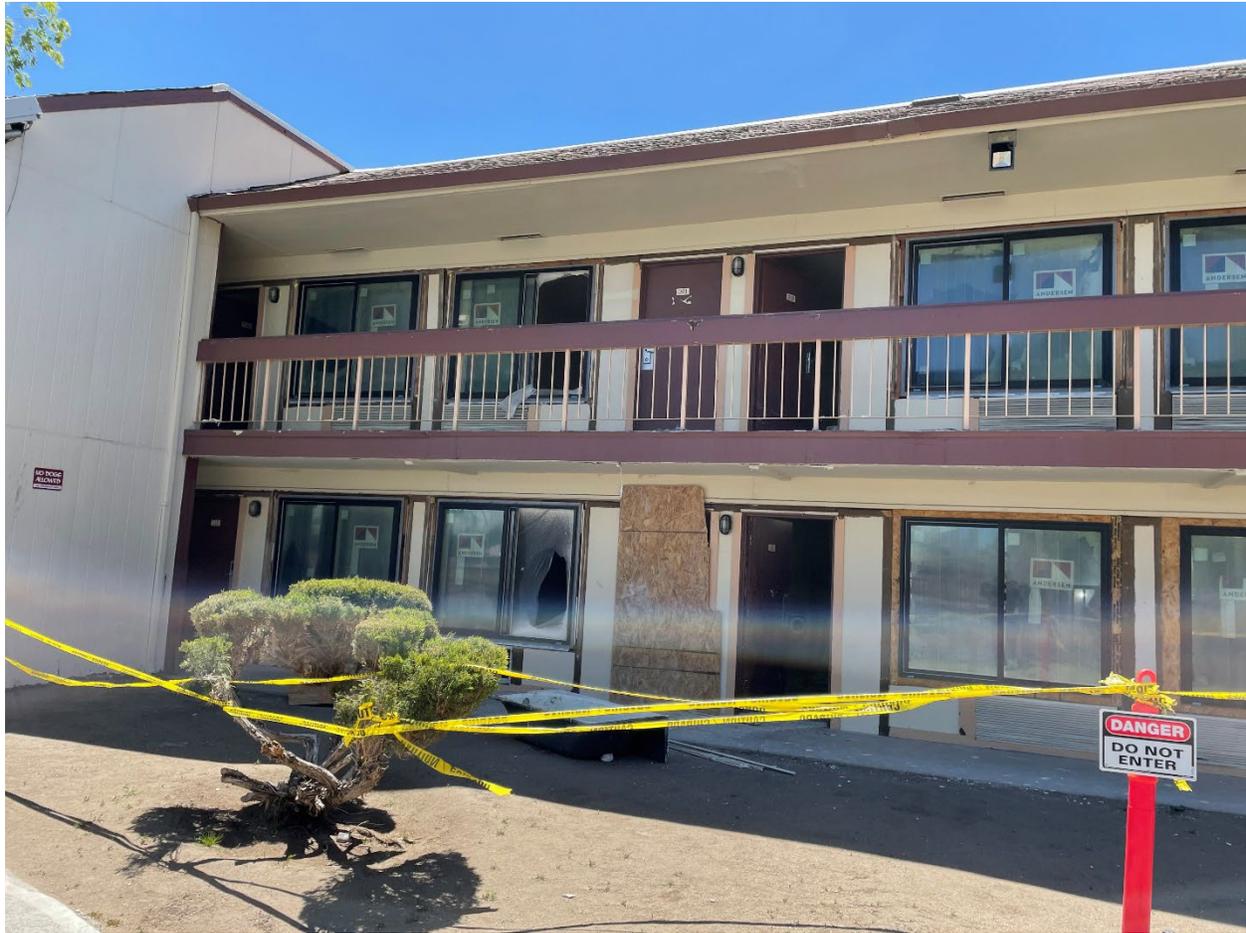
**Photograph 7**

This photo shows the area of renovation on the north side of the facility. Asbestos containing debris is visible on the ground and in the landscaping.

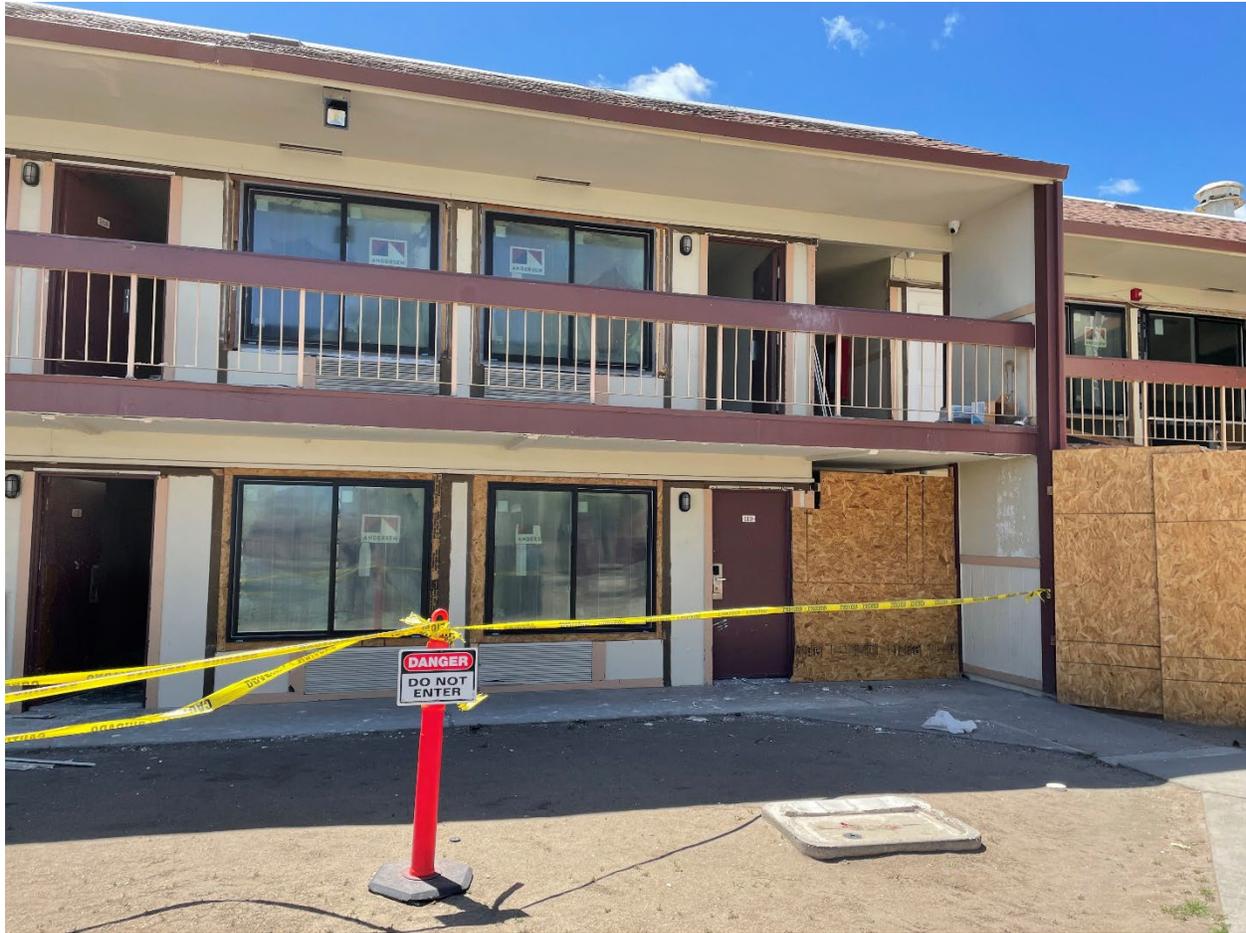
**Photograph 8**

This photo shows the area of renovation on the north side of the facility. Asbestos containing debris is visible on the ground and in the landscaping.

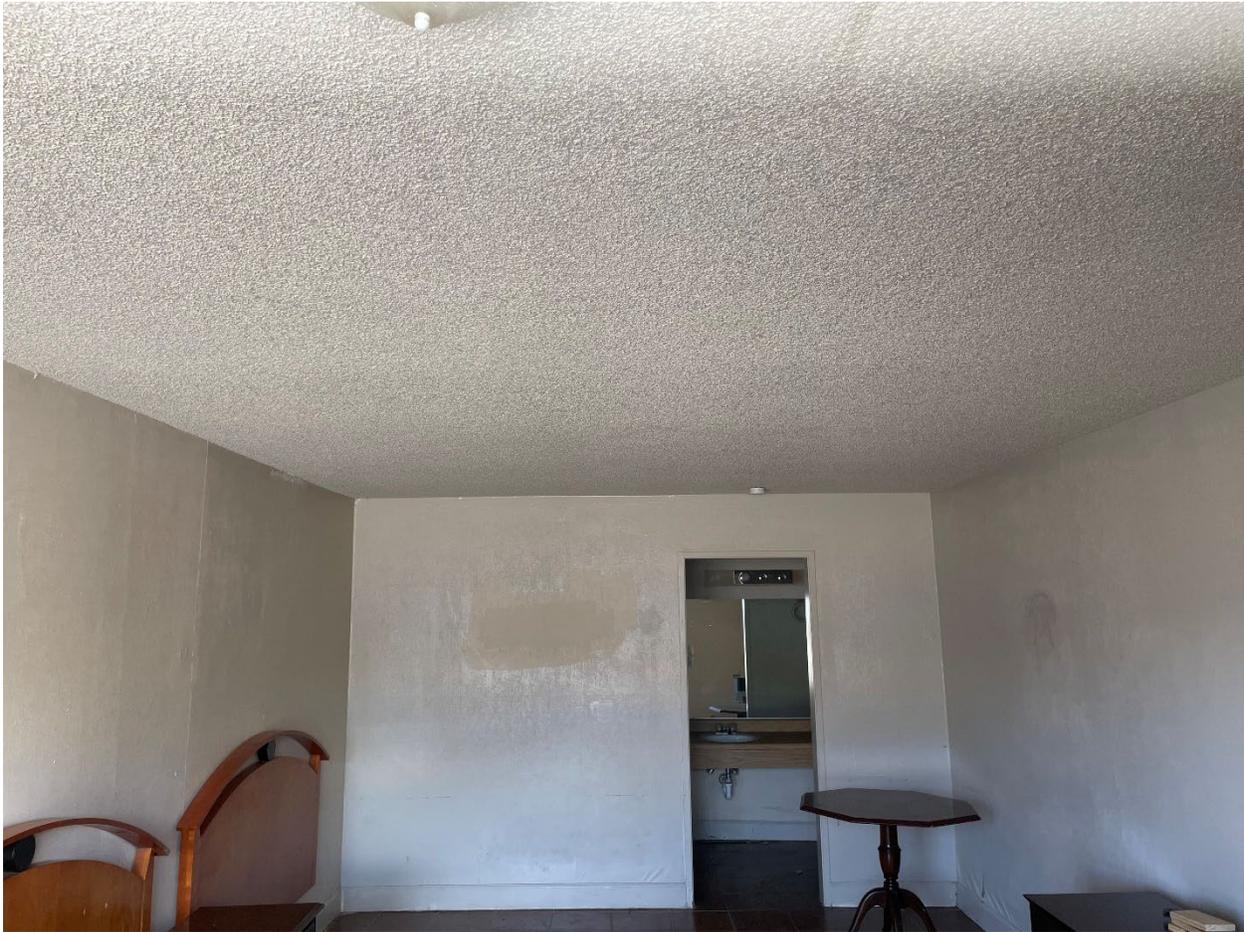
**Photograph 9**

This photo demonstrates the inside of room 142, a guest room which was not being renovated at the time of the response. This is an example of the asbestos containing spray acoustic ceiling texture present in the guest rooms at the facility.

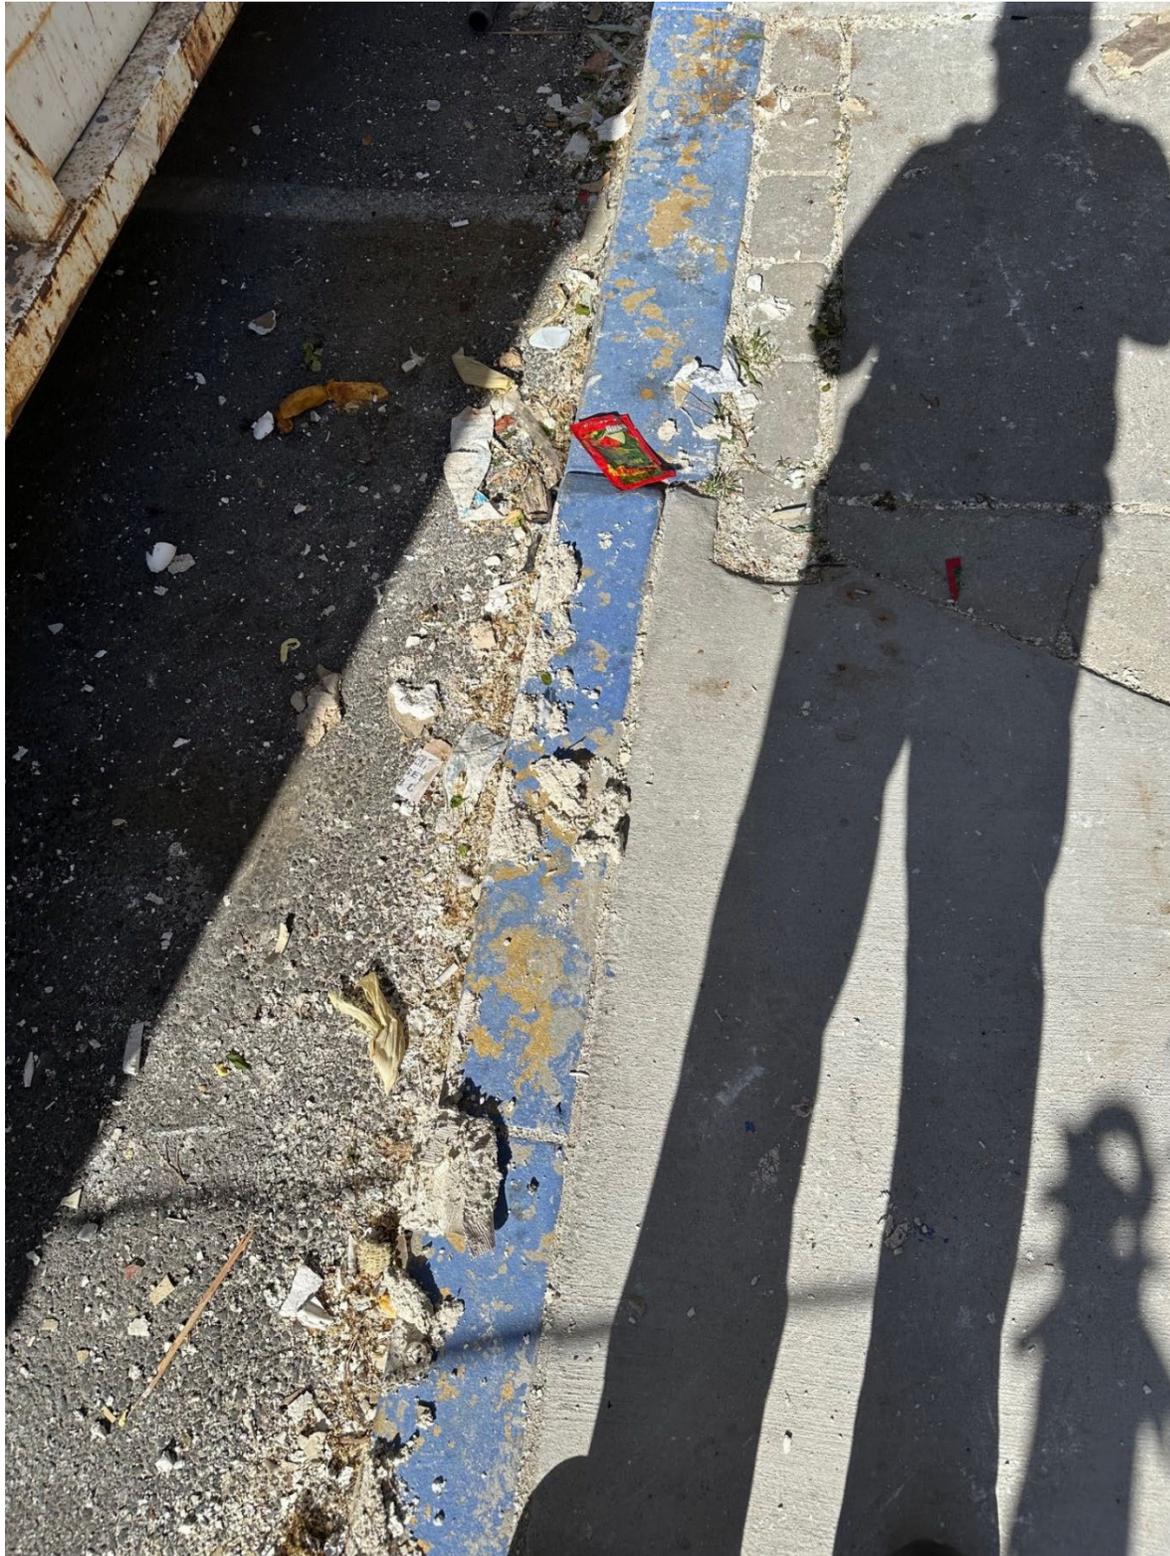
**Photograph 10**

This photo shows asbestos containing debris on the ground adjacent to the dumpster. The material on the ground along the curb edge was sampled for asbestos (sample #2). The sampled material on the curb edge appeared to have been scraped from workers shoes.

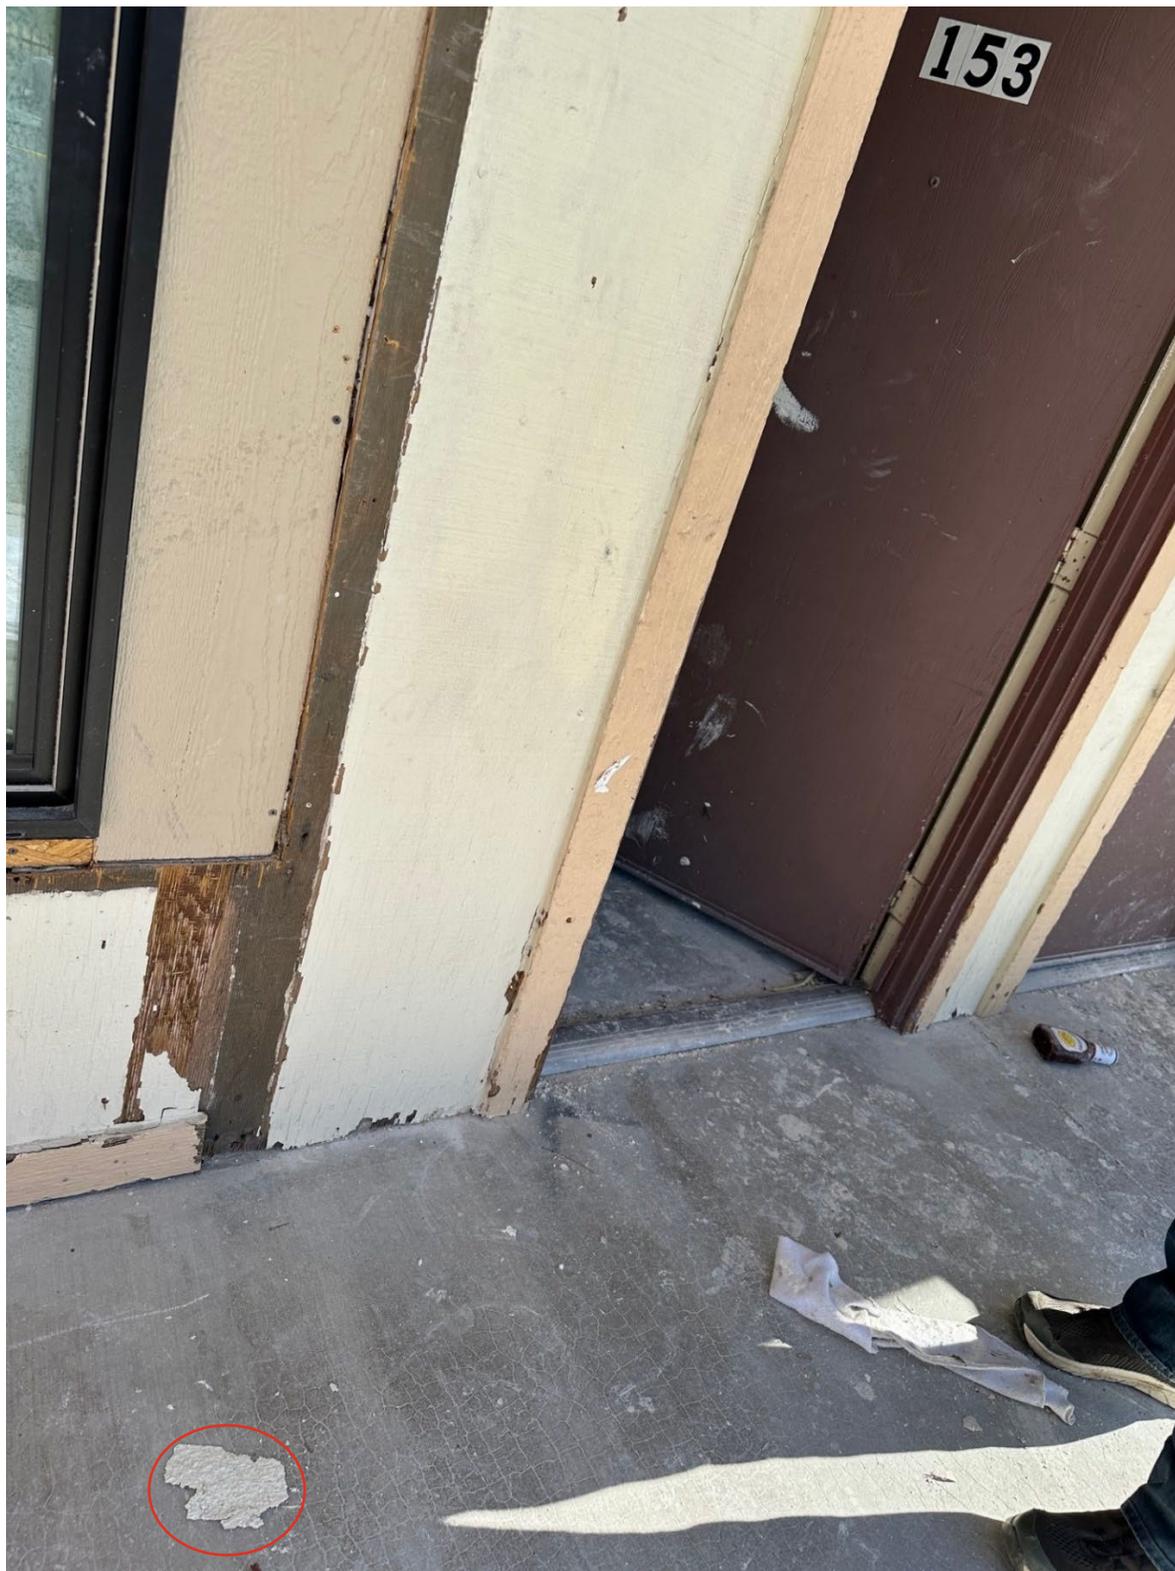
**Photograph 11**

This image demonstrates a large piece of asbestos containing spray acoustic ceiling texture debris found on the ground outside room 153 which was being renovated. The spray acoustic ceiling debris is in the lower left corner of the photo. The debris was collected and tested positive for asbestos (sample #3).

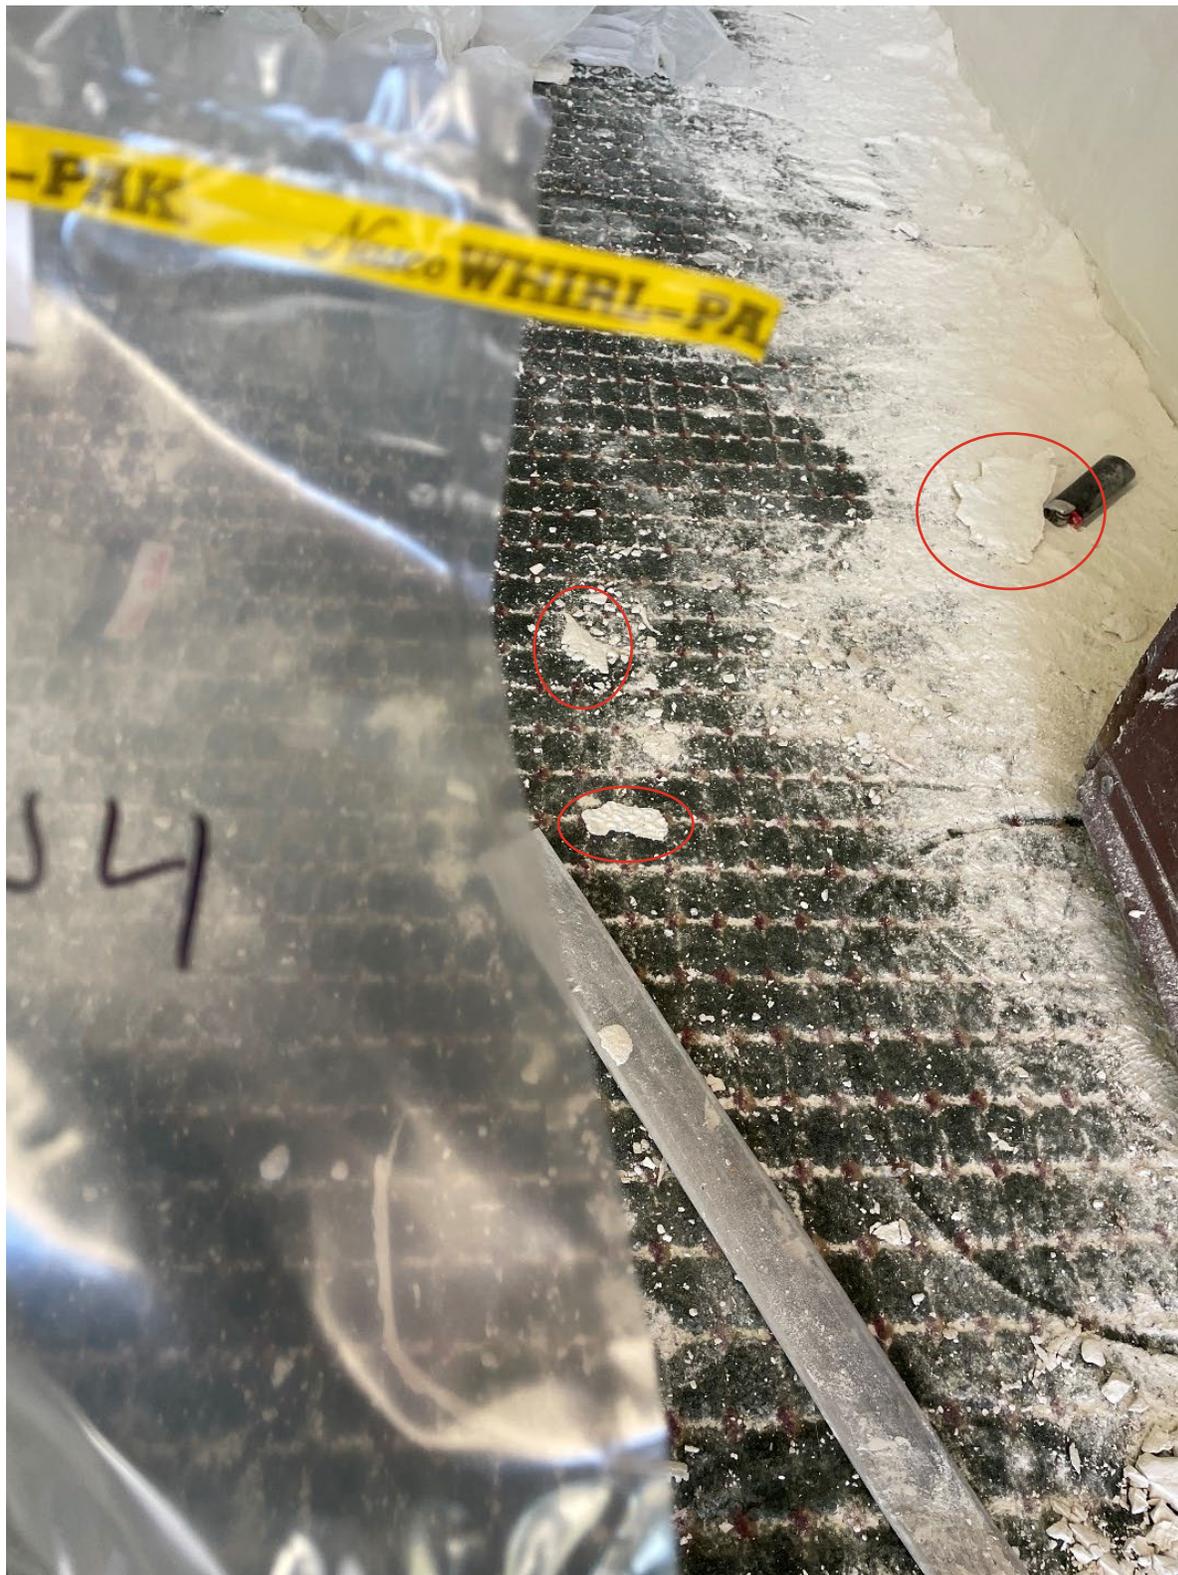
**Photograph 12**

This image demonstrates pieces of asbestos containing spray acoustic ceiling texture debris found on the ground inside room 253 which was being renovated. The spray acoustic ceiling debris is in the center and adjacent to the lighter in the photo. The debris was collected and tested positive for asbestos (sample #4).
