**LIMITED ASBESTOS CONTAINING MATERIAL  
INSPECTION AND ASSESSMENT: 3131 SOUTH  
VIRGINIA STREET, RENO, NEVADA CONDUCTED  
MARCH 17/APRIL 17, 2023**

**RE: LIMITED ASBESTOS CONTAINING MATERIAL INSPECTION AND ASSESSMENT: 3131 SOUTH VIRGINIA STREET, RENO, NEVADA**

**AREA OF IMPROPER ASBESTOS DISTURBANCE  
AND REMOVAL**

## **PHOTOGRAPHIC DOCUMENTATION**

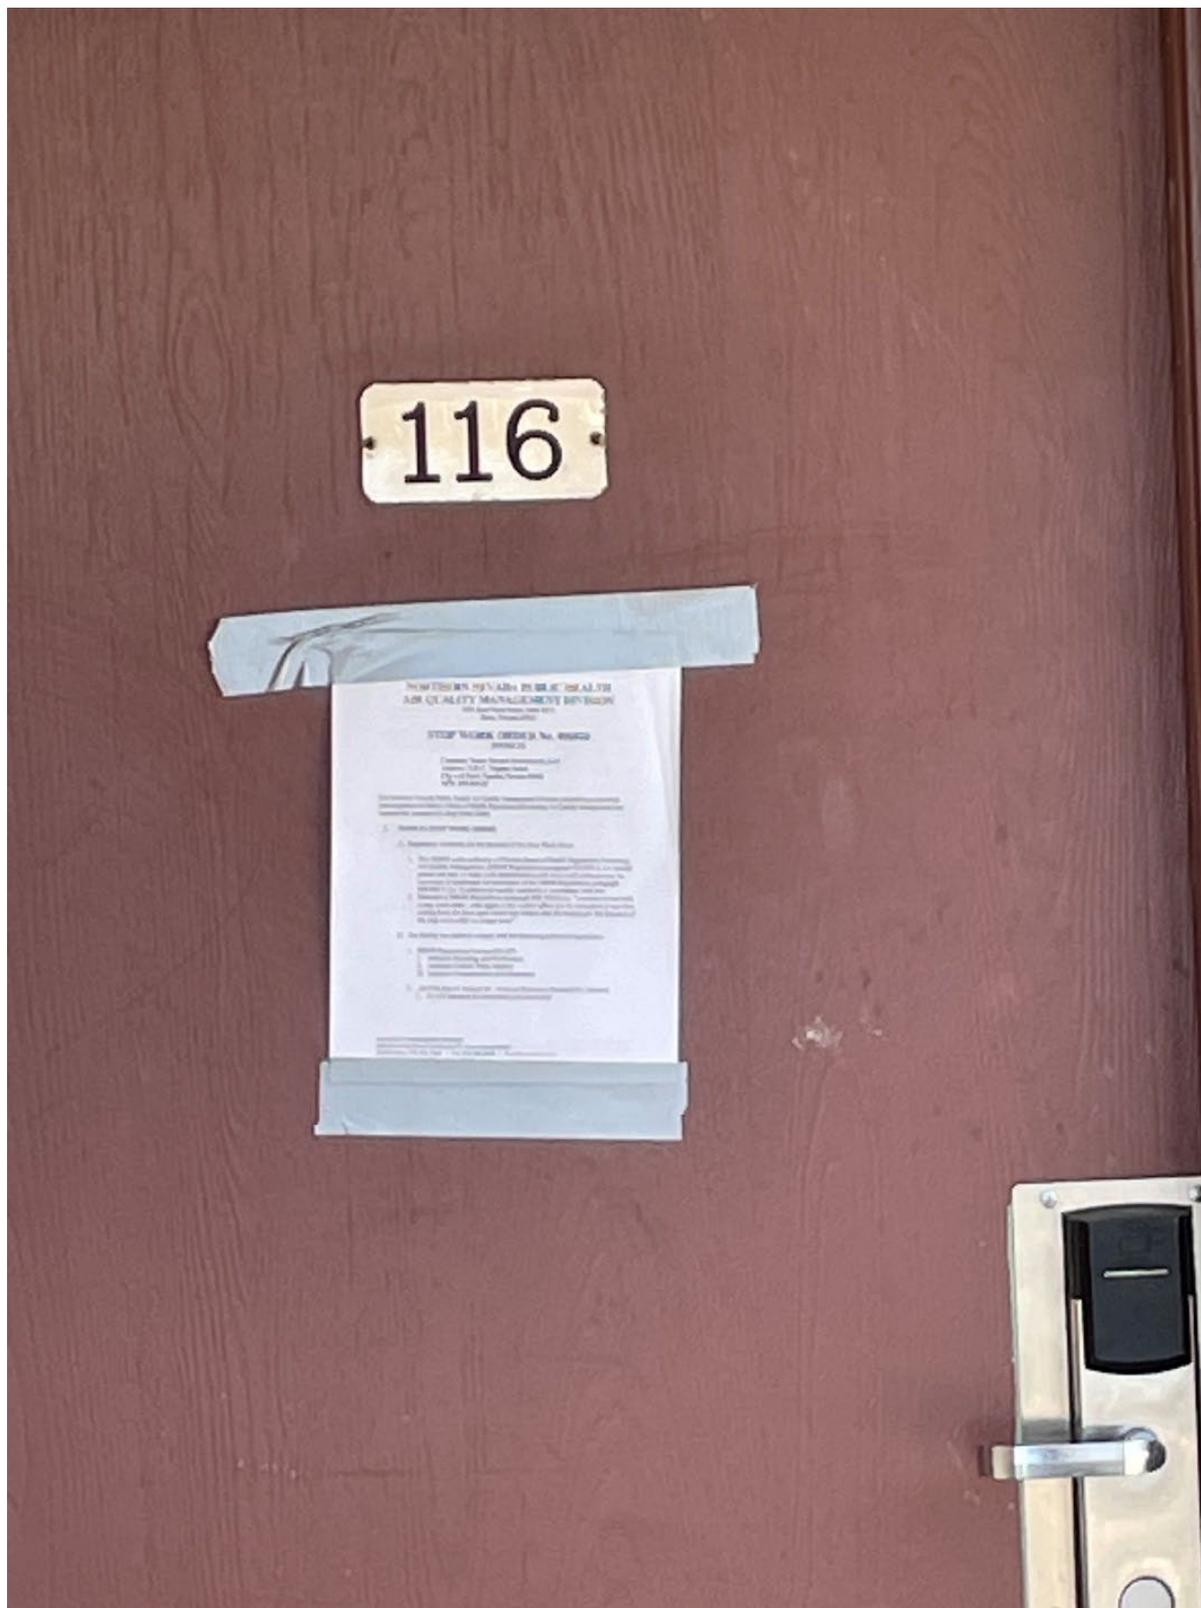
**Photograph 13**

This image demonstrates an example of the posting of Stop Work Order No. 00010. The Stop Work Order was posted throughout the active renovation area and on the dumpster.
